# Manhole Inspection Summary

Manhole # **S13GG1019MH**

**Location** Address: **4259 PARK HEIGHTS AVE**

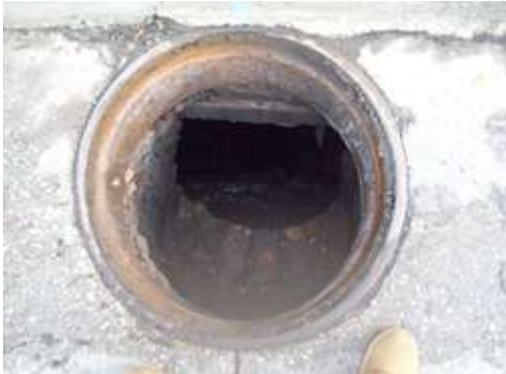
Defect 1

Condition: ☐ Sound ☐ Cracked ☐ Root Intrusion ☒ **Loose Brick** ☐ Deteriorated

LOOSE BRICKS ON CORBEL

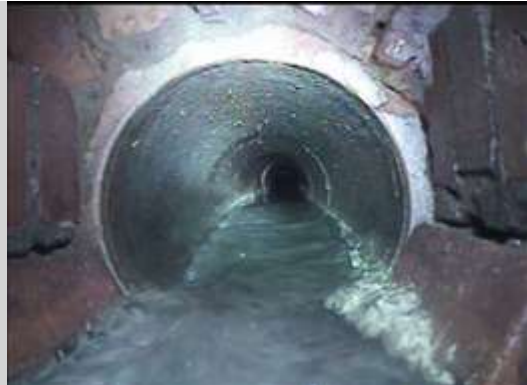
12 O'Clock Outflow

8 in. Circular Gravity Sewer  
Pipe Out @ 12 O'Clock

Pipe Height: (in.) Direct  
Pipe Material: **Clay** ☐ Pipe Lined  
Invert Depth: **7.58** (ft.) Flow Characteristics: **Fast**  
Deposits: ☒ None ☐ Mud ☐ Sludge ☐ **Debris** ☐ Grease  
Silt Depth: (in.) Deposits Extent:  
Infiltration: **None** Pipe Seal Cond: **Cracked**

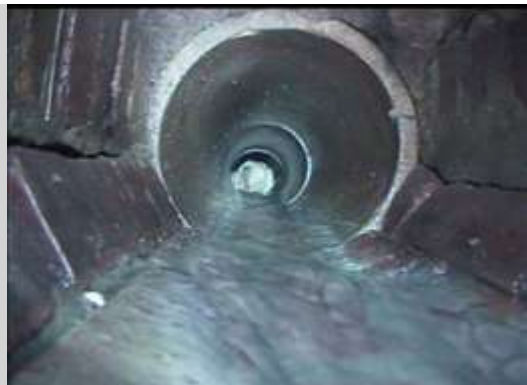
6 O'Clock Inflow

8 in. Circular Gravity Sewer  
Pipe In @ 6 O'Clock

Pipe Height: (in.) Direct  
Pipe Material: **Clay** ☐ Pipe Lined  
Invert Depth: **7.56** (ft.) Flow Characteristics: **Fast**  
Deposits: ☒ None ☐ Mud ☐ Sludge ☐ **Debris** ☐ Grease  
Silt Depth: (in.) Deposits Extent:  
Infiltration: **None** Pipe Seal Cond: **Sound**

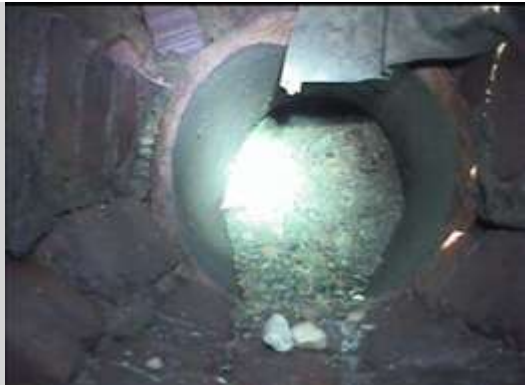
9 O'Clock Inflow

Deposits: ☐ None ☐ Mud ☐ Sludge ☒ **Debris** ☐ Grease

Silt Depth: **1** (in.) Deposits Extent: **Light**
